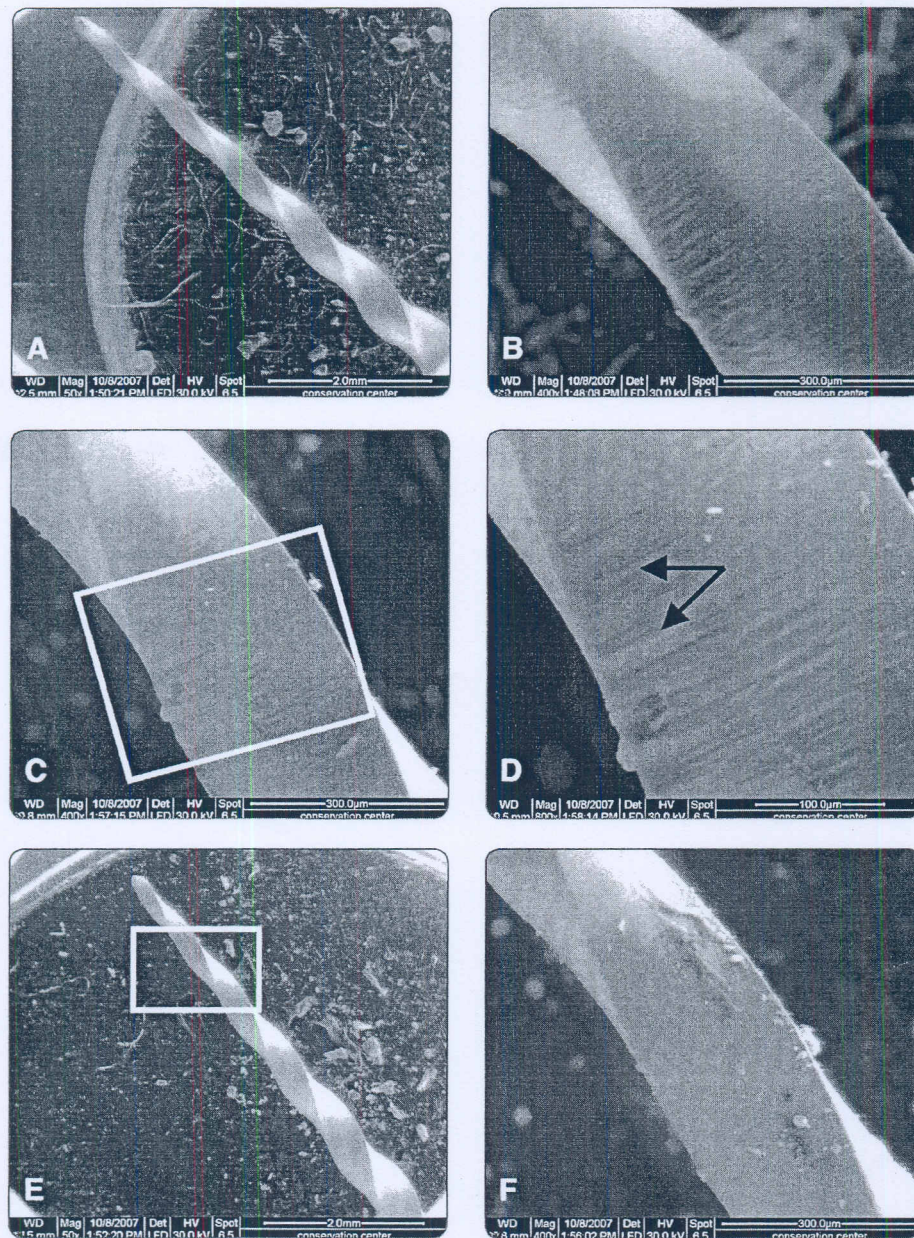
Fig. (2): SEM micrograph of a representative sample of PTU retreatment instrument size D2 a: as received: note the uniform flutes, b: regular machine grooves, no blade irregularities, wear or surface pitting (original magnification a50x & b400x). c: D2 PTU after unfilling of 6 canals, Grain defect (widening of machine grooves) is apparent at the center of instruments' flute, blades shows blunting and irregularities (400x).d: A higher magnification of the previous micrograph; note the irregular blade (arrows) and the disruption and widening of the machine grooves at the flutes' center (800x). e: PTU used in unfilling of 8 canals; marked distraction at the file's second flute was detected (white rectangle) (50x). f: Higher magnification of the previous micrograph; note the severe instruments' distraction (distortion) and cracking, blade blunting and irregularities as well as debris accumulation are also seen (original magnification 400x).

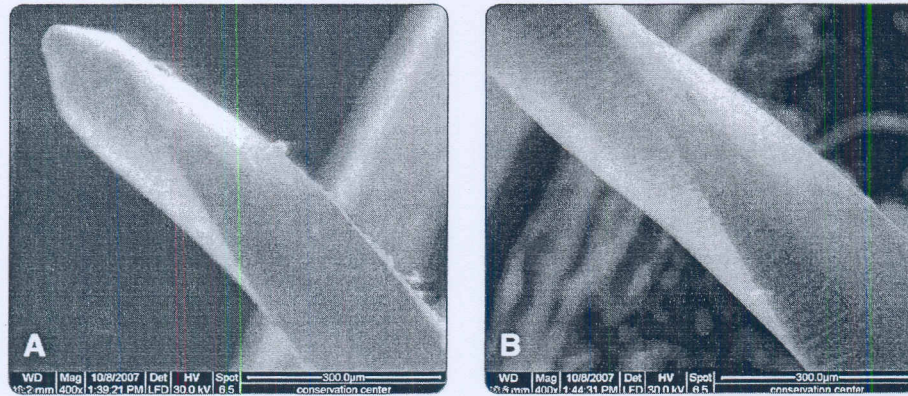
Fig.3: Composite SEM micrograph of a size # D3 PTU instrument's tip and part of the shaft after unfilling of 4 canals. Few debris accumulations were shown near to the instrument's tip (a). (b) revealed starting of features of blade blunting (original magnification 400x)

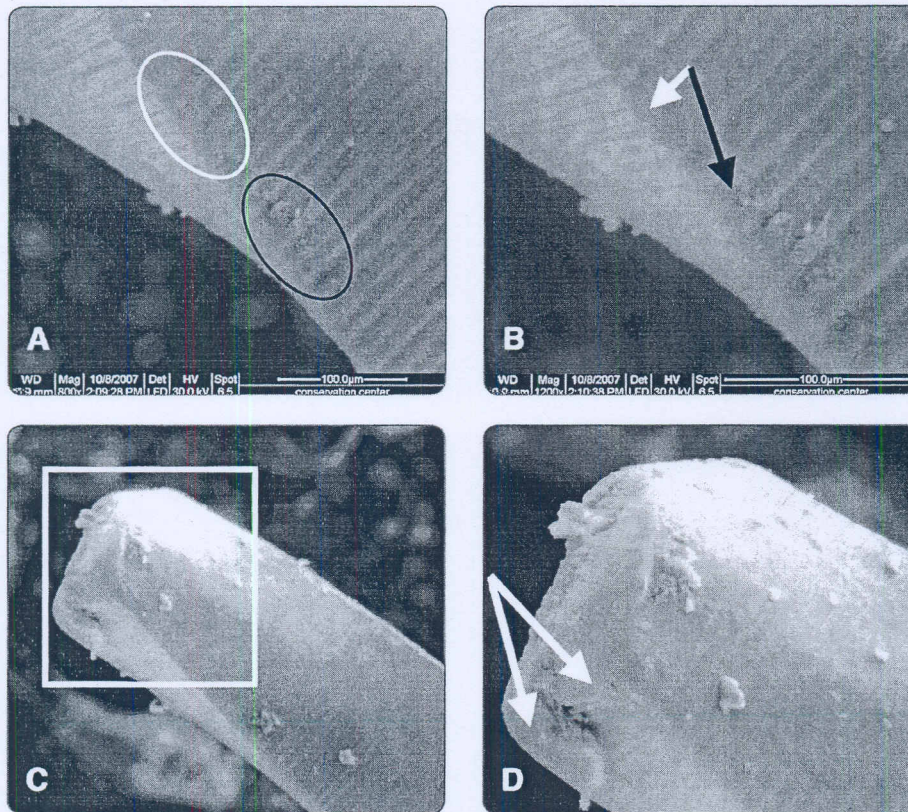
Fig 4 : SEM photomicrographs showing: a: marked irregularities (white circle), wear, and turn over (black circle) of the instrument's blade after 6 canals' unfilling (original magnification 800x). b: A higher magnification of the previous micrograph showing blade wear and irregularities as well as surface pitting (arrows) after 6 canals' unfilling (1200x). c: SEM Micrograph of the PTU files' tip after 8 canals unfilling. Total tip destruction was noted in a D2 instrument. Tip has completely worn and disappeared – not separated- as shown from the alloy turn over (arrows) 400x. d: A higher magnification of the previous micrograph, note the tip disappearance and metal turnover (arrows) (original magnification 800x).
